**EFC WP16, 10th meeting,
EUROCORR'2004, Nice, Sept. 14, 2004**

THE PROBLEMATIC OF DISBONDING OF COATINGS AND CORROSION WITH BURIED PIPELINES CATHODICALLY PROTECTED

**Marcel ROCHE
Head of Corrosion Department
TOTAL S.A.**

Recent experience with 18'' oil Rabi-Cap Lopez pipeline (Gabon)

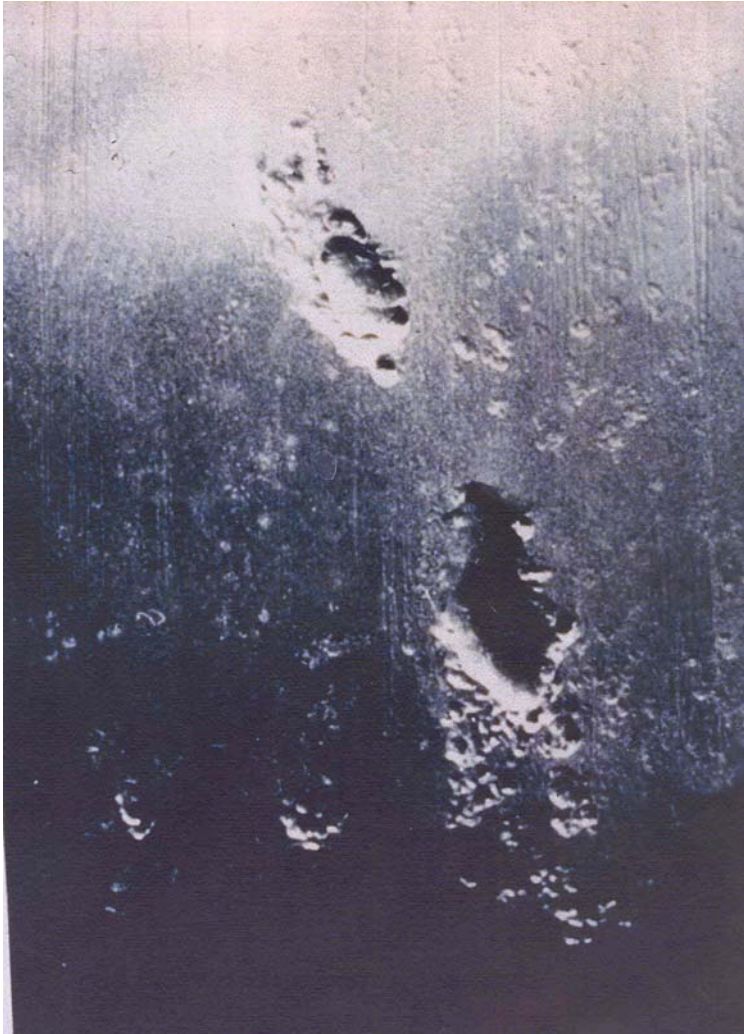
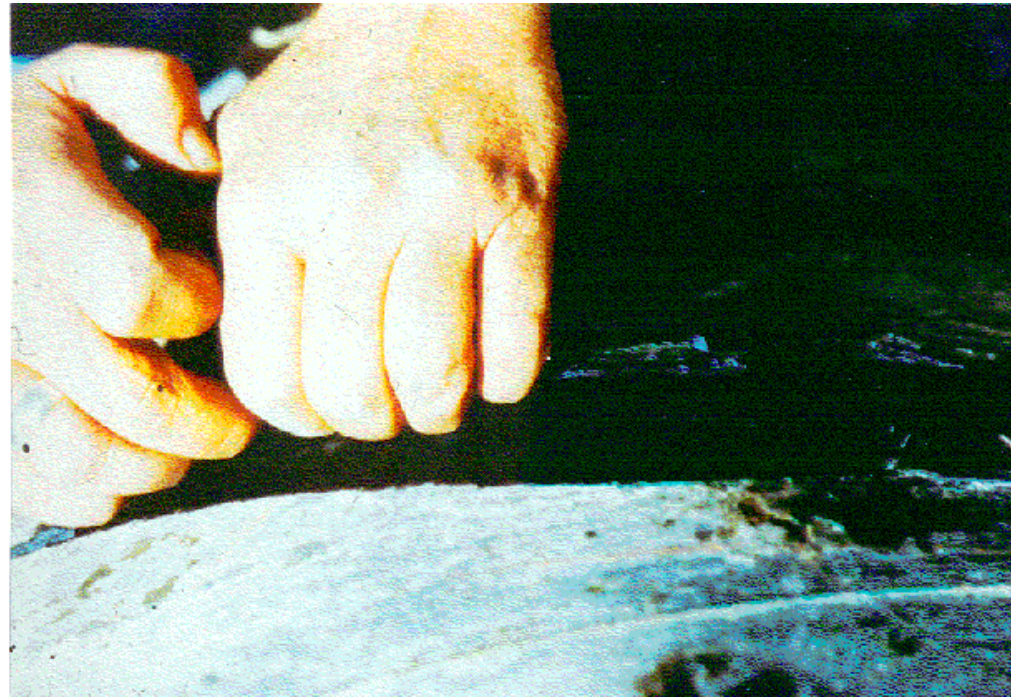
Corrosion underneath a disbonded asphalt enamel coating on buried onshore pipeline

Until recently, only onshore buried pipelines coated over the ditch with enamels or tapes were found corroded

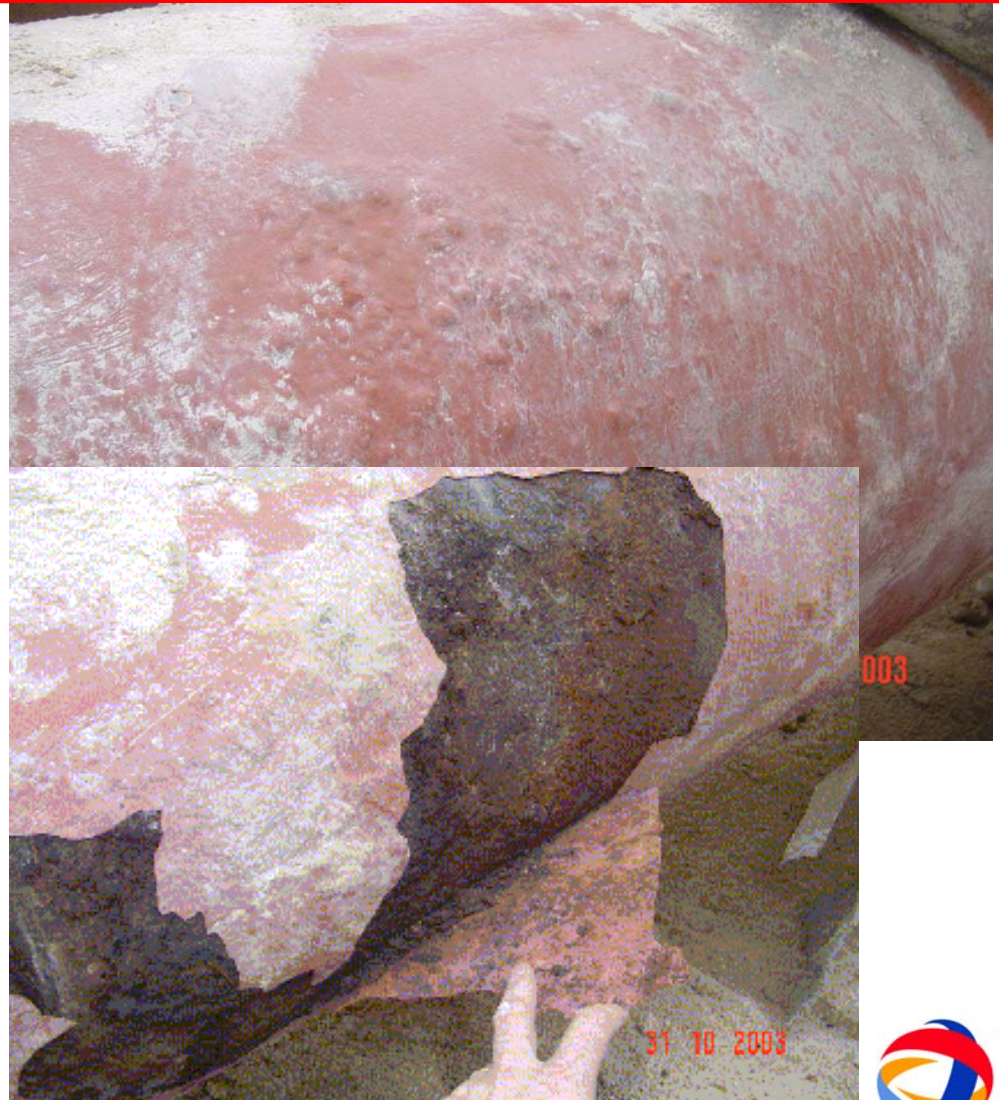
Corrosion underneath a disbonded FBE coating on buried onshore pipeline

- Corrosion under disbonded FBE occurred on an onshore buried pipeline transporting hot heavy fuels from La Mède refinery to Fos-sur-mer storage facilities
- 18", 7.9mm, 8.9km, laid in 1988, 0.42mm FBE, Tg 100°C
- Operating temperature fluctuating between 40 and 80 °C
- Corrosion locations detected since 1998 through intelligent pigging and DCVG

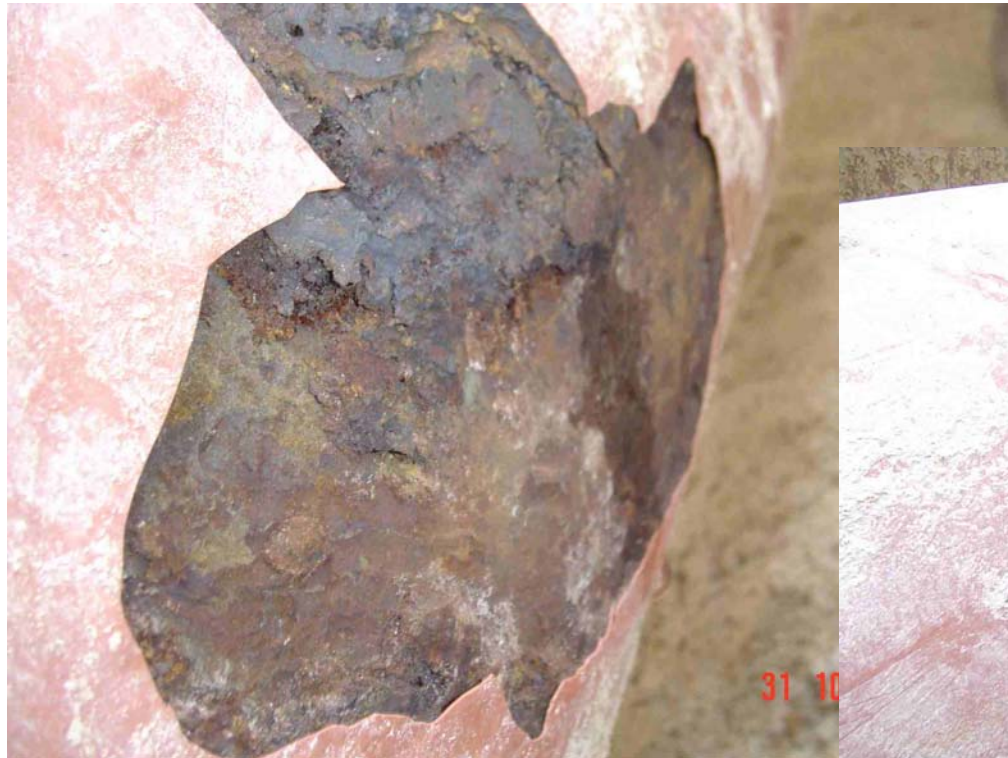
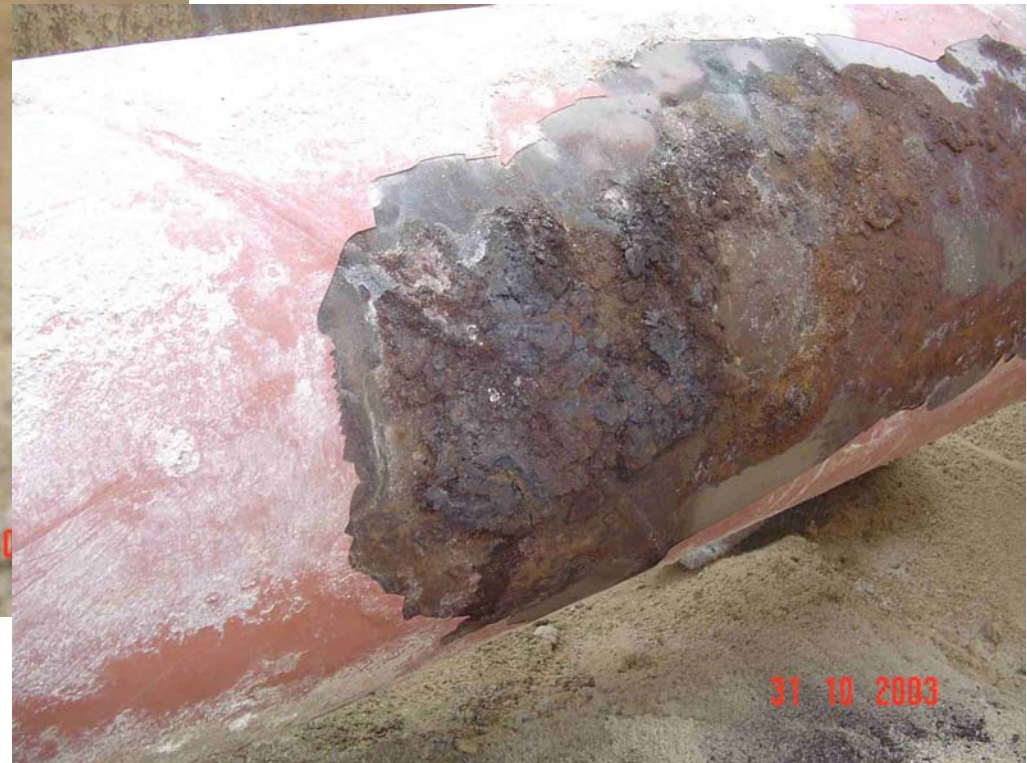
Corrosion underneath a disbonded FBE coating

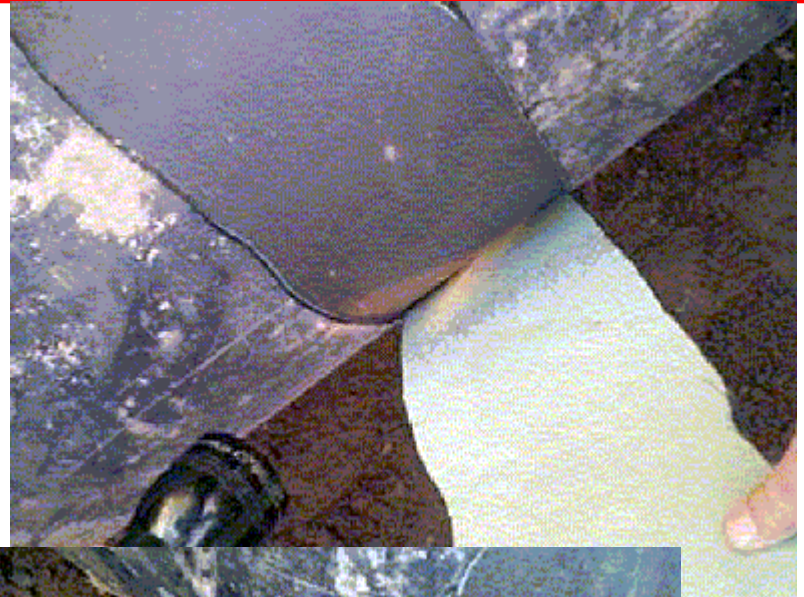
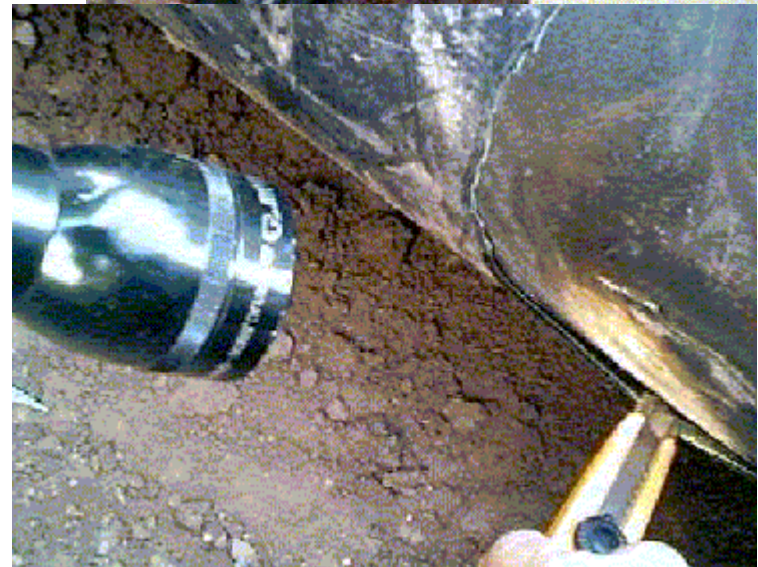
- **16'' oil pipeline laid in 1994 in Syria**
 - discovered during repair works carried out due to mechanical damage
 - measured ON potential: $-1.6 \text{ V/Cu- CuSO}_4$
 - disbonding between epoxy primer and steel, without any trace of corrosion
- **Pipeline in Argentina**
 - No precise information

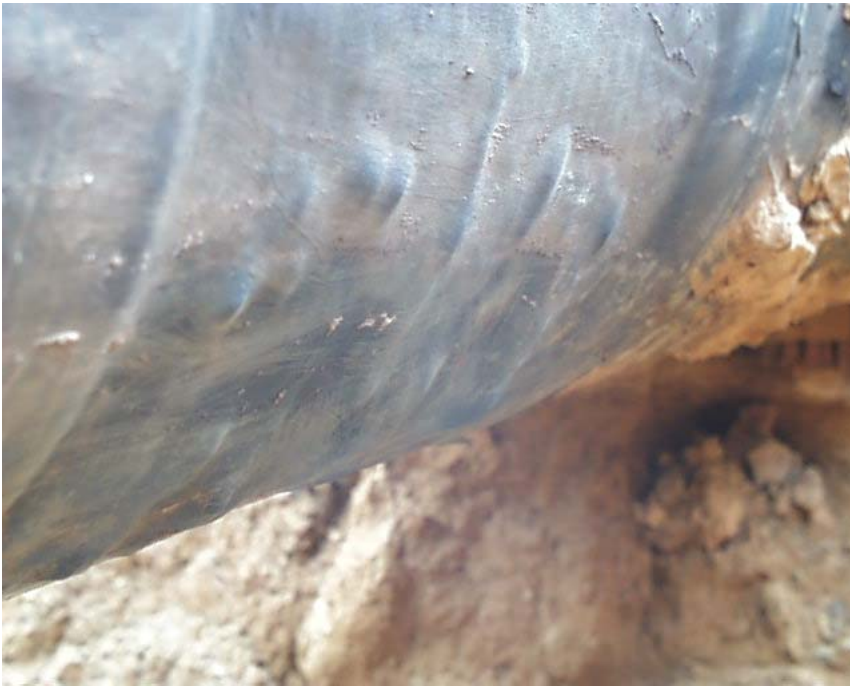
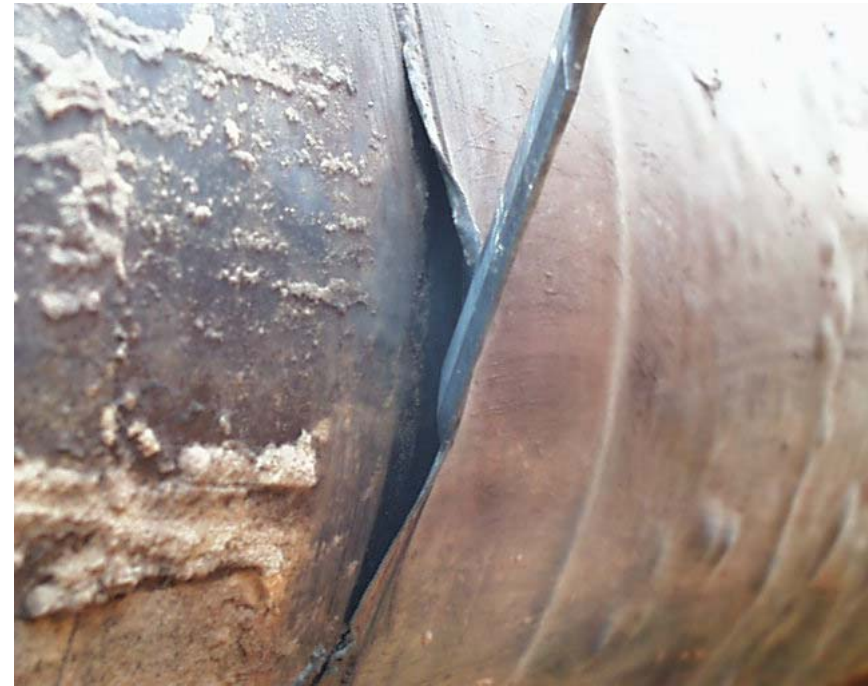
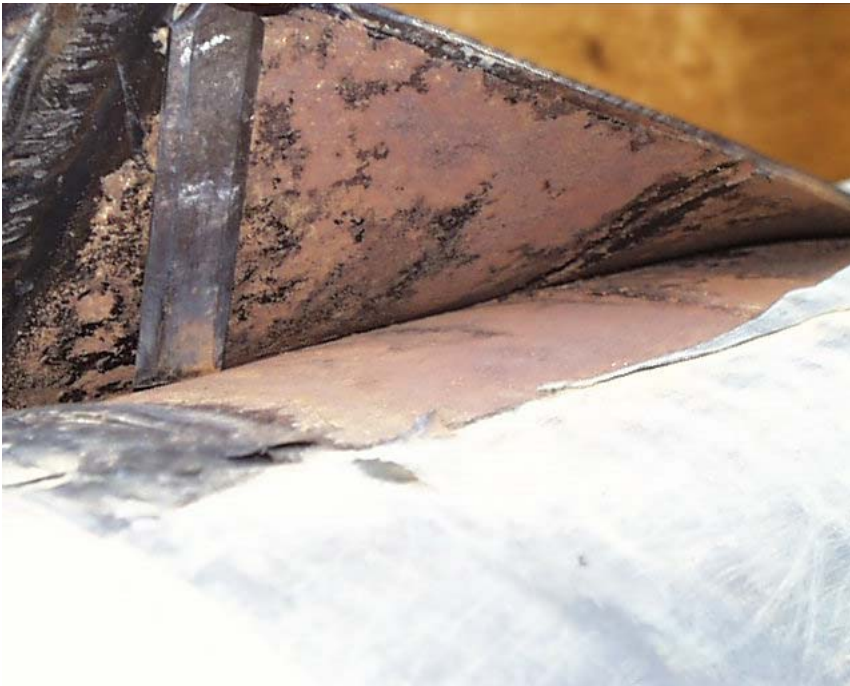
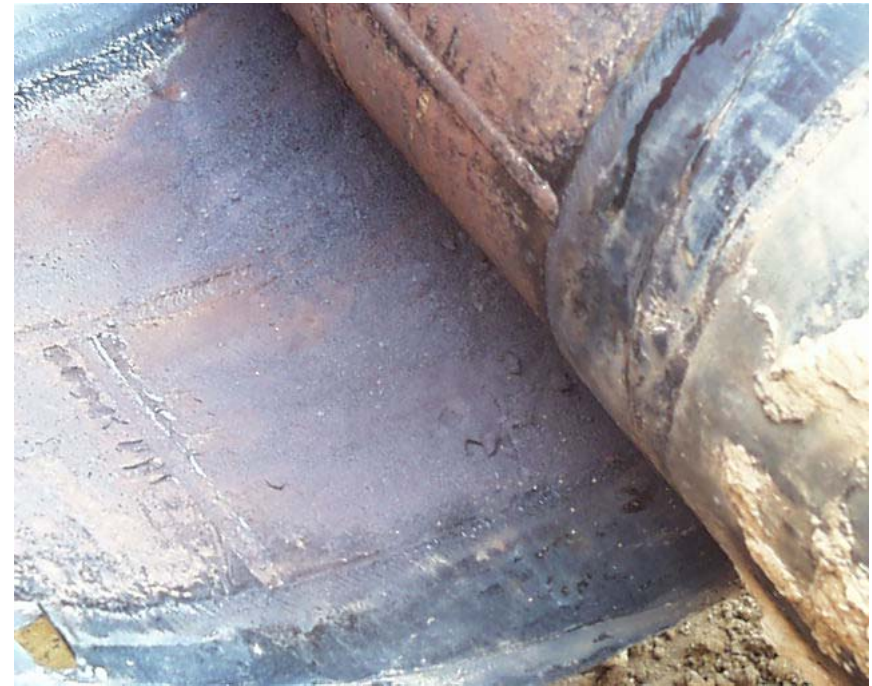
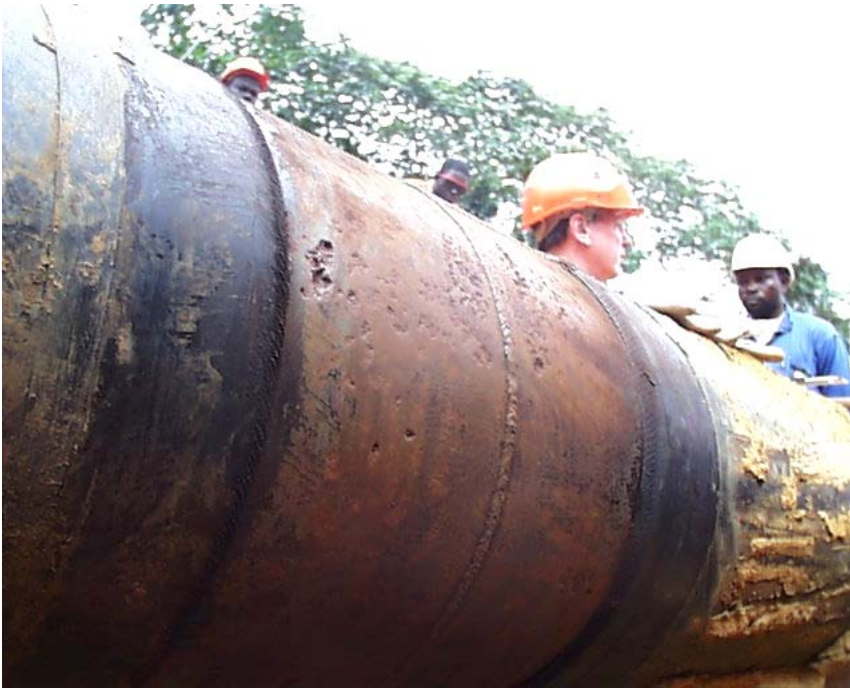
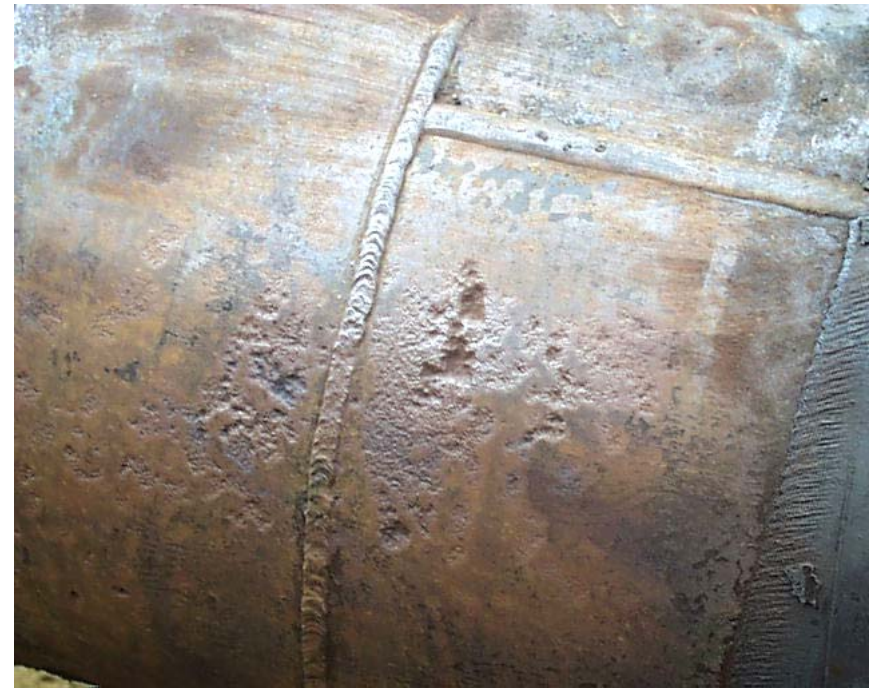
- **The major part of corrossions are under field joint coatings at girth welds: massive disbonding of HSS with steel** leading to corrosion caused by shielding effect
- Excavations reveal that in spite of a correct installation concerning applied heat shrinkable sleeves – no residual witness green points- and molten adhesive on the whole circumference, but **lack of bonding on plant applied PE coating** due to brushing limited to bevels of coating

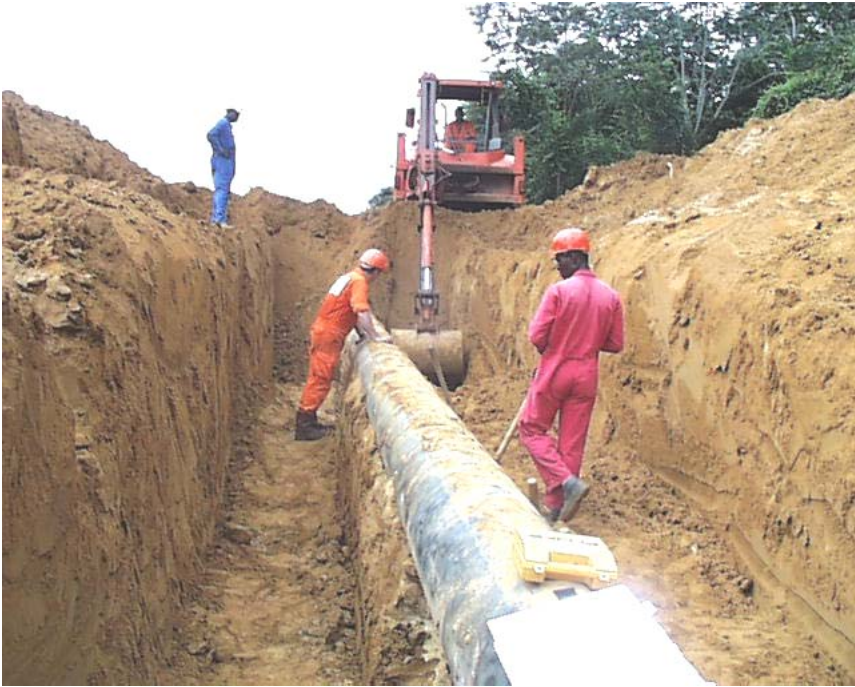
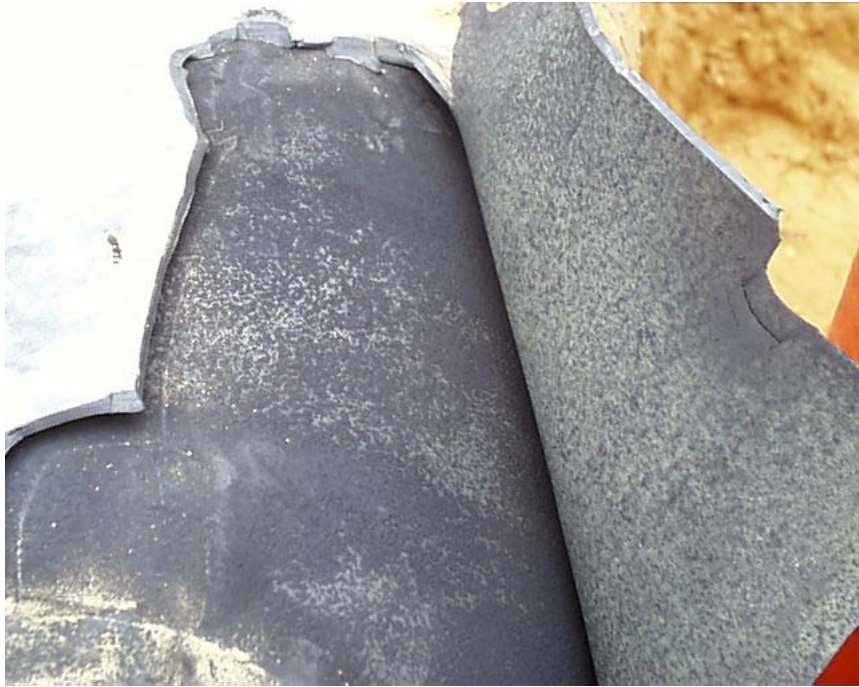
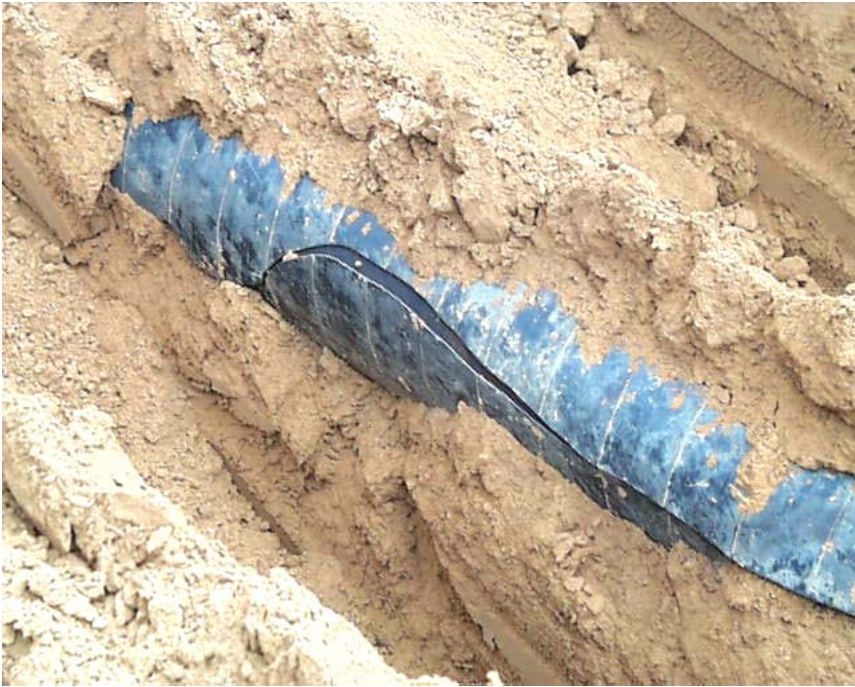
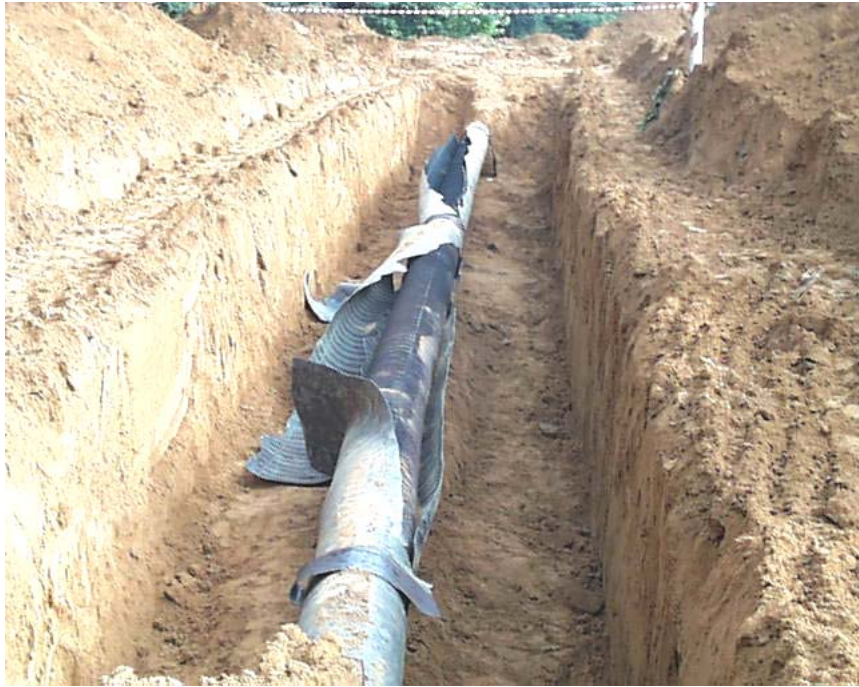
- **3LLDPE plant applied coating** generally appears externally OK but found **fully disbonded** (when cut with a tool) **between FBE and steel**
- **Corrosion under PE plant-applied coating on some pipe lengths** (46 tubes, all in the first 13 km, except 1)
- Excavations show that in this case PE coating is **longitudinally cracked and opened at 3 and 9 o'clock**
- Presence of a **black powder** on steel surface (under HSS and plant-applied PE). Analysis shows it is mainly magnetite Fe_3O_4 and goethite $\text{Fe}_2\text{O}_3 \cdot \text{H}_2\text{O}$ + pyrrhotite Fe_7S_8 and $\text{Fe}_2(\text{OH})_2\text{CO}_3$)
- **No correlation between cracking/opening and bending during laying** (4 pipes bent over 46)

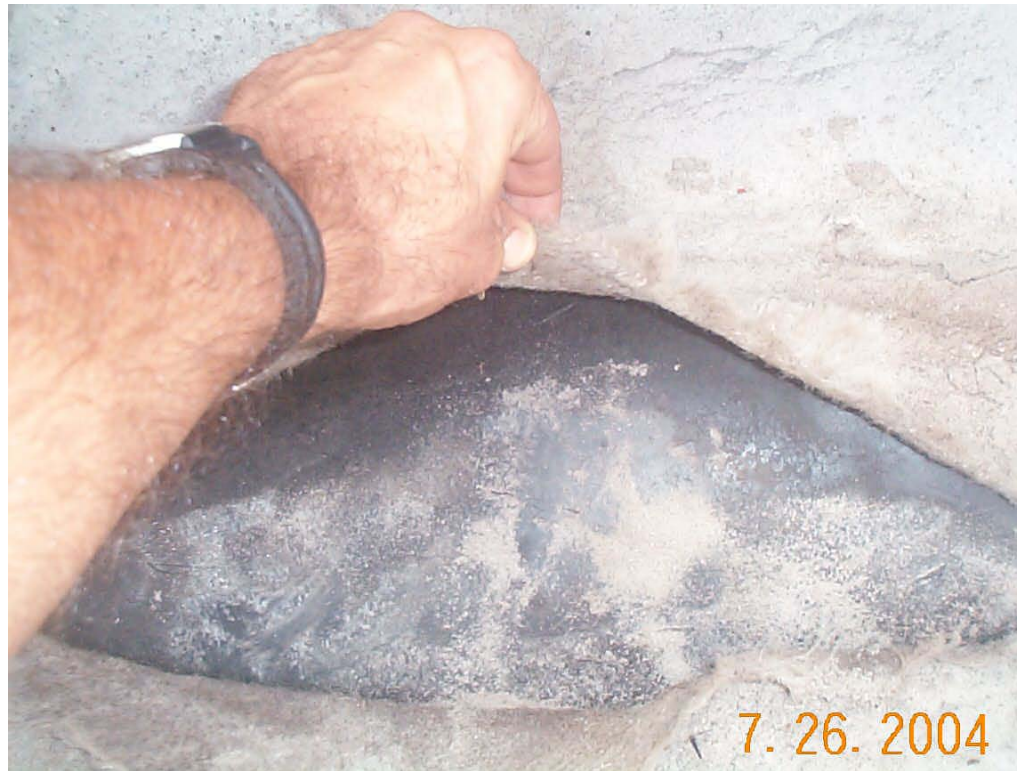
- Recent excavation at Tchenghé on **section 3** (started in 1997) reveals **no disbonding and no corrosion**
- Very wet area, PE coating covered with Bidim
