# Corrosion in Seawater

Stein Olsen

Statoil

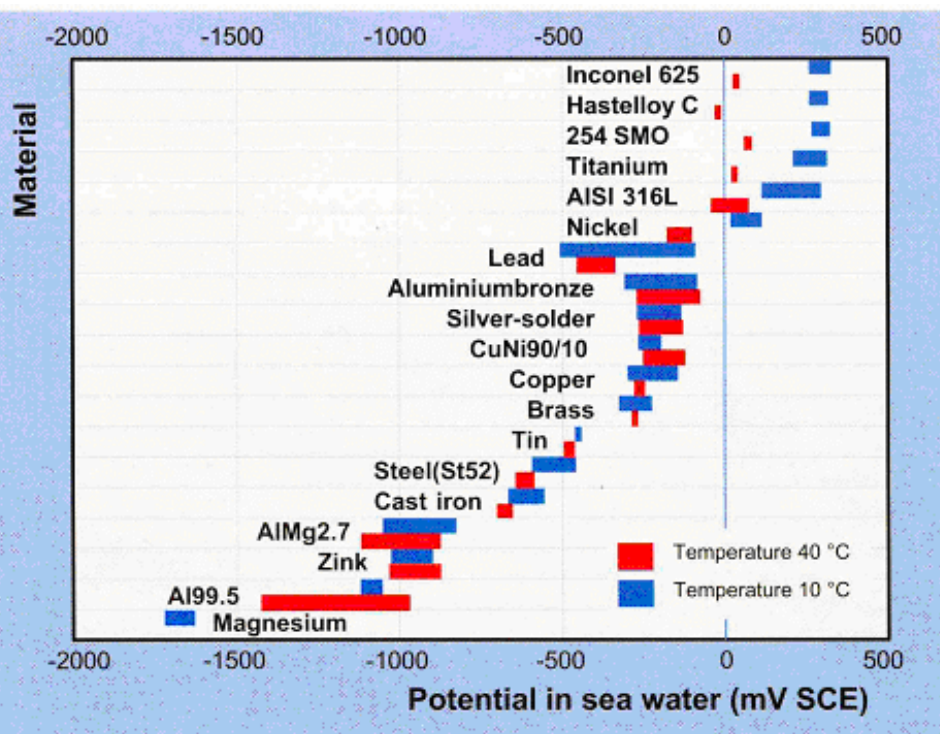
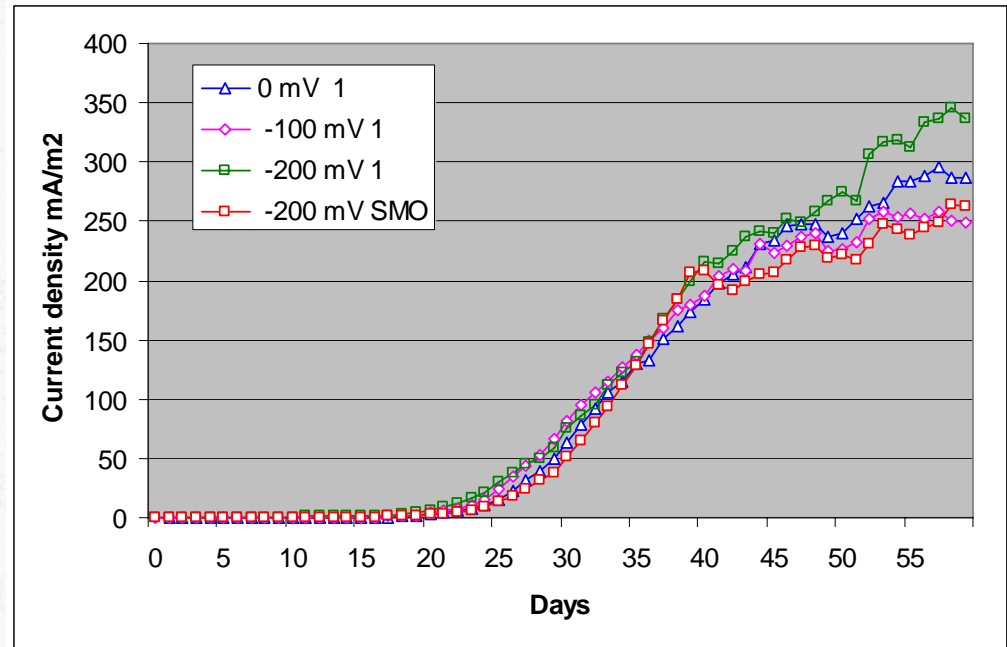
# The discovery of the biofilm!

- Increase in potential and cathodic capacity
- Time delay for removal of seawater in non resistant CRAs
- Temperature and time effect – galvanic series

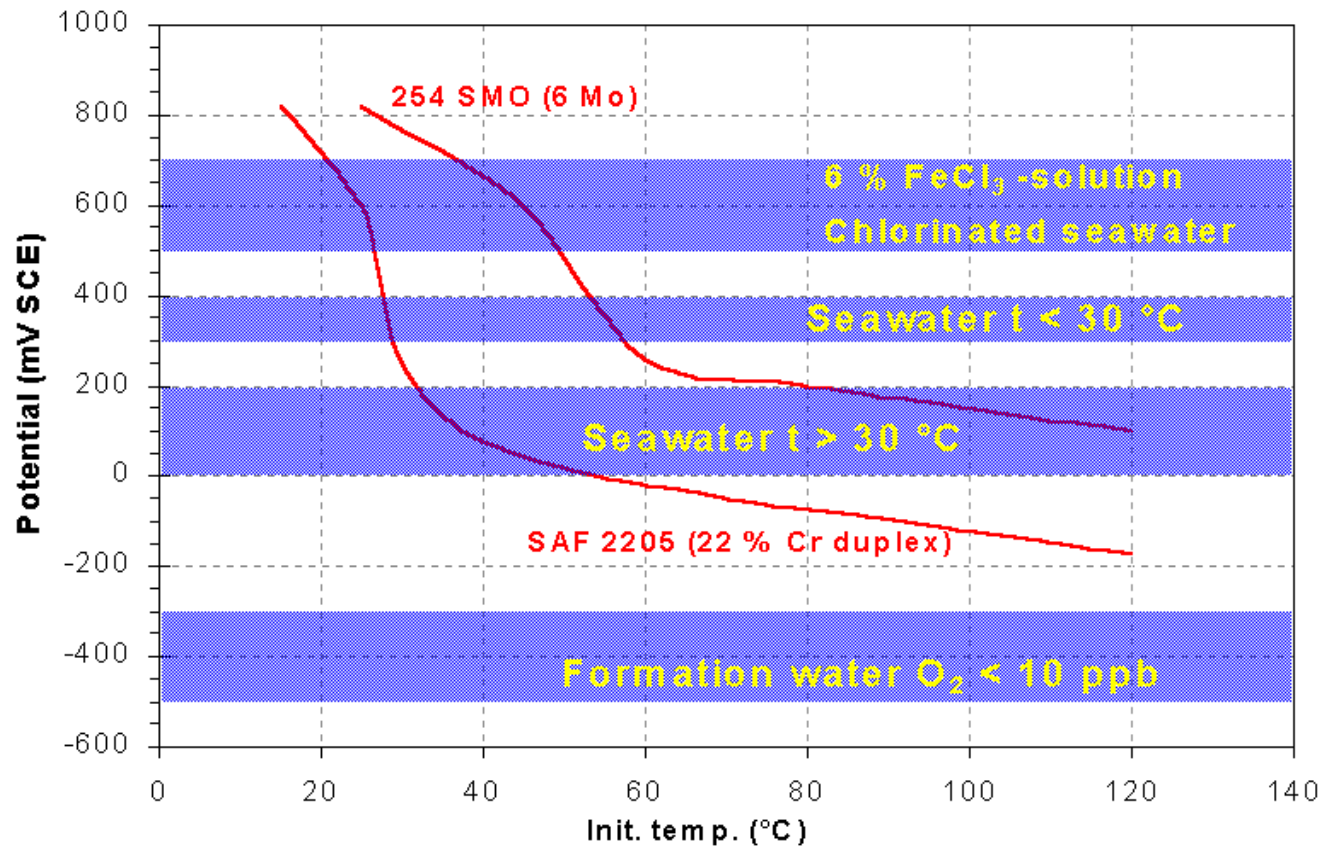
# CPT and CCT as a function of potential

Critical temperature as a function of electrochemical potential for welded specimens

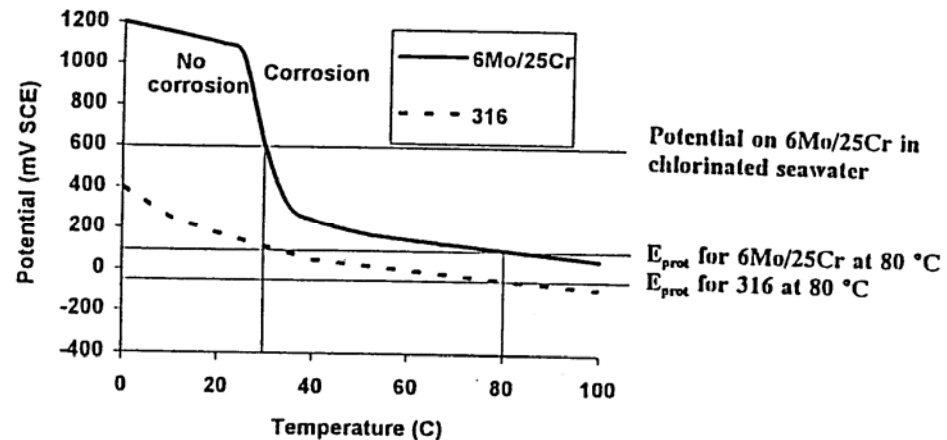
Schematics of the RCP method applied to a piping system.

# RCP

- Chlorination to prevent formation of the biofilm that enhances the cathodic capacity
- Stainless steel with a repassivation T  $\sim 0$  mV SCE for actual temperatures (PREN > 40)

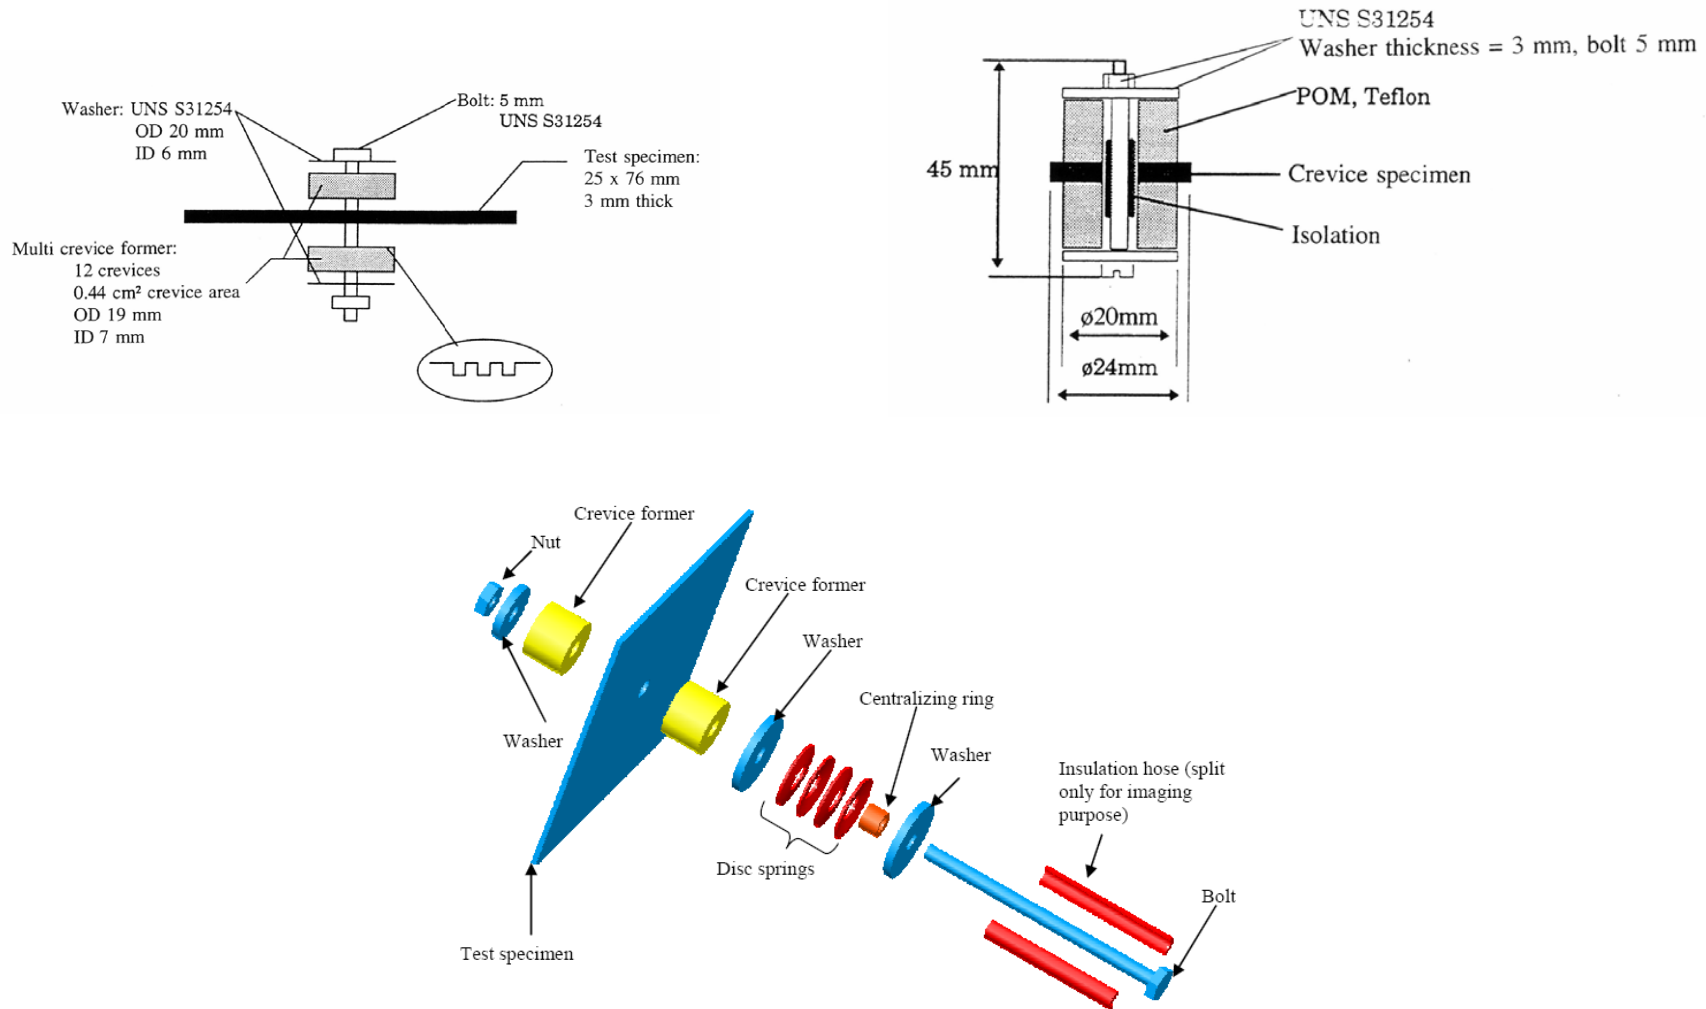
Figure 3.3 Crevice corrosion assembly developed during the CREVCORR project /8, 9/.

- Titanium limited delivery – long lead time!
- Ni-alloys as alternatives
  - C-276, A-686, A-59....
- Testing
  - Laboratory with artificial crevices
  - Testing with real assemblies – different results !
