History of EFC-WP 11 “Corrosion in Concrete“

Univ.-Prof. Dr.-Ing. Michael Raupach, Institute for Building Materials Research, ibac,
Aachen University,

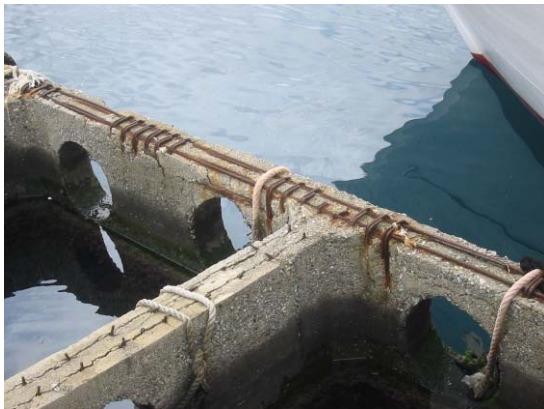
Figure 1. Example for chloride induced reinforcement corrosion in concrete exposed to seawater

In the 1960s first major damages on concrete buildings induced by reinforcement corrosion have been documented. Since about 1975 the amount of damages is increasing considerably resulting in the fact, that in the meantime reinforcement corrosion has become one of the major problems of maintaining the infrastructure. Most critical are structures exposed to chloride environment like offshore of coastal structures exposed to seawater (see e.g. Figure 1) or bridges or parking garages exposed to de-icing salts (see e.g. Figure 2).

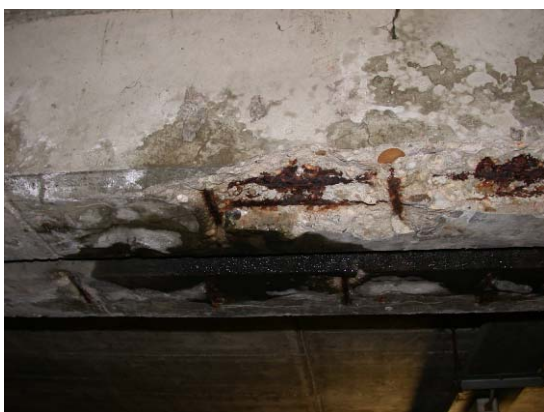
Figure 2. Example for chloride induced corrosion of the reinforcement exposed to deicing salts within a leaking joint of a parking garage

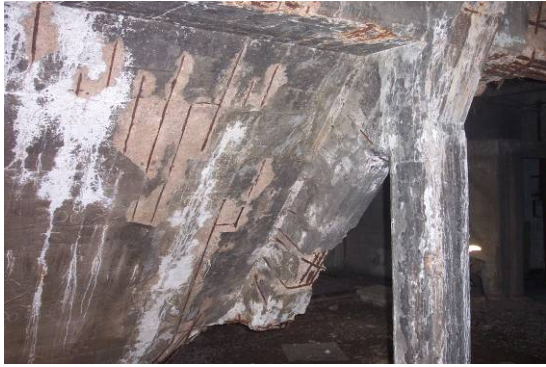
Figure 3. Corrosion of the reinforcement of an old concrete structure caused by insufficient concrete cover

However, also carbonation of the concrete can lead to depassivation of the steel and subsequent corrosion of the reinforcement, especially when the concrete cover is too low (see e.g. Figure 3) or in cases of insufficient compaction of the concrete (see e.g. Figure 4).

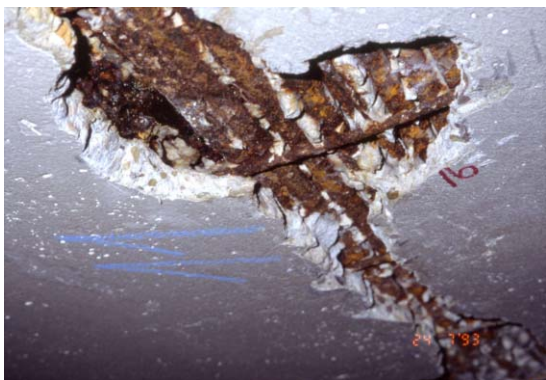
Figure 4. Corrosion of the reinforcement caused by local bad compaction of the concrete

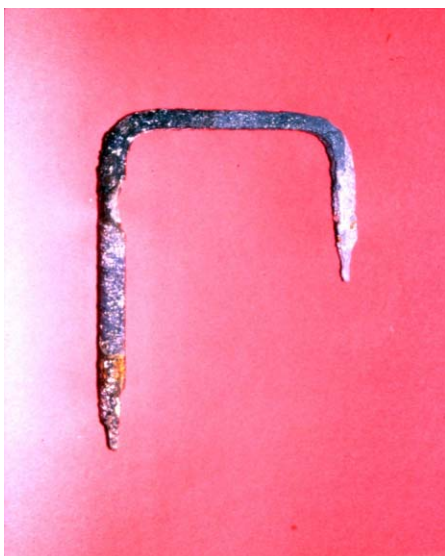
Figure 5. Corroded rebar from a 4 years old building in hot and salty environment

Under aggressive environments the corrosion rates can exceed 1 mm/a or more. Figure 5 shows a rebar which is partially corroded away in the area of a crack in hot and salty environment within 4 years. However, in more moderate climates the corrosion rates are usually lower, but they are still critical: Figure 6 shows a rebar from a parking garage in Germany which has been removed from the area of a wide crack, where de-icing salts had passed through for about 10 years. The loss of cross section has proceeded so far that the remaining load bearing capacity of the steel is negligible.

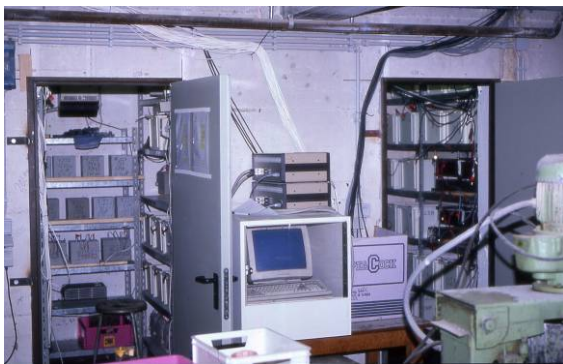
Figure 7. Example of electrochemical testing of rebar corrosion in concrete specimen

When corrosion of the reinforcement in concrete structures had been realised to be a serious problem world-wide in the 60th and 70th and the amount of damages still increased considerably in the 80th, extensive research programs had been initiated to understand the mechanisms of reinforcement corrosion and to become able to assess, repair and maintain those structures appropriately. Reinforced concrete probes with cable connections to each rebar have been produced extensively to study the potentials, polarisation behaviour, macrocell effects and the influences of the concrete mix as well as the environmental conditions like temperature, humidity, chloride content, etc (see e.g. Figure 7).

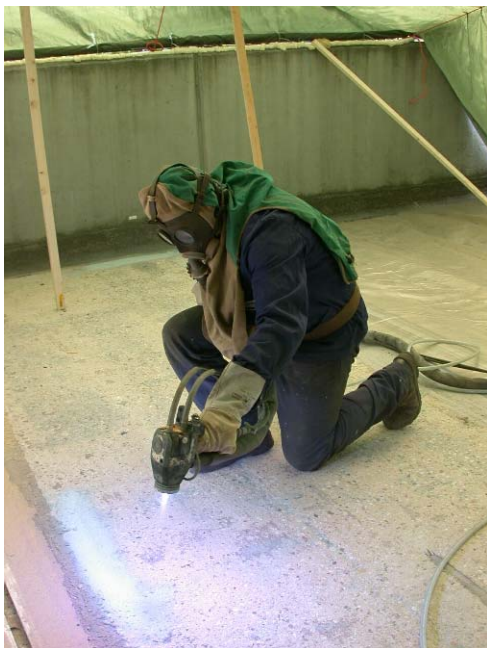
Figure 8. Sacrificial cathodic protection of steel in concrete by thermal zinc spraying

Especially for cathodic protection several different anodes systems have been developed, which were discussed in detail in WP 11. As examples Figure 8 shows the thermal spraying of a zinc layer to the concrete surface acting as sacrificial anode and Figure 9 the installation of a carbon mesh into a special connecting mortar as impressed current CP-system.

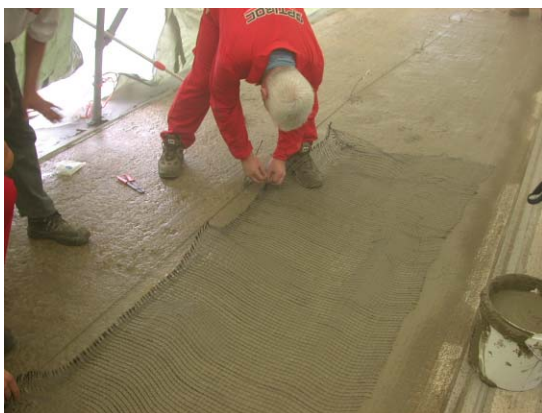
Figure 9. Cathodic protection by an impressed current using a carbon mesh anode in a special mortar

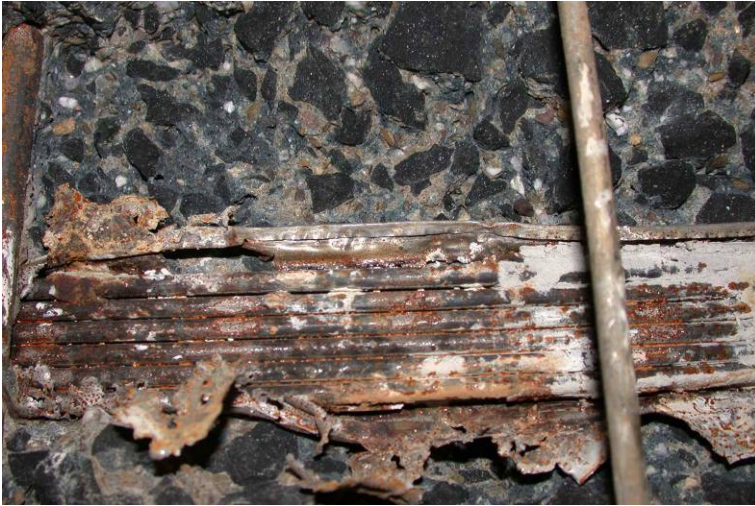
Figure 12: Corroding prestressing steels after opening of the duct

Besides the risk of hydrogen induced embrittlement also pitting corrosion of prestressing steels has been discussed (see Fig. 12).

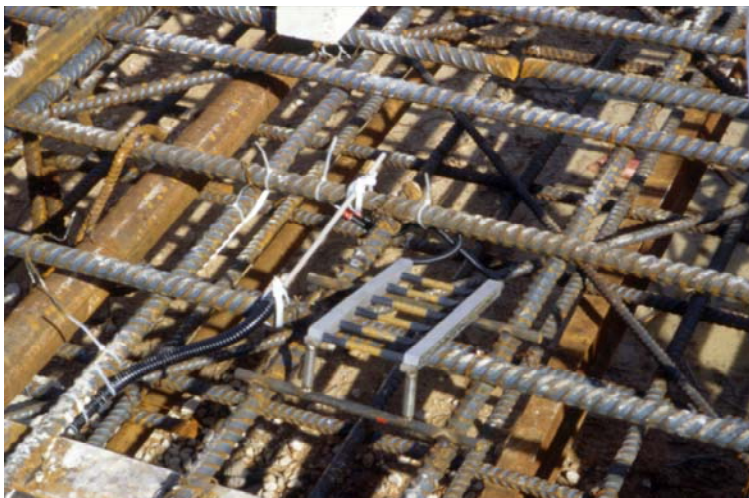
Figure 13. Sensors installed in a concrete structure to monitor the corrosion risk for the reinforcement

Interesting input data for modelling are available from corrosion monitoring systems in actual structures (see e.g. Figure 13) or exposure tests.

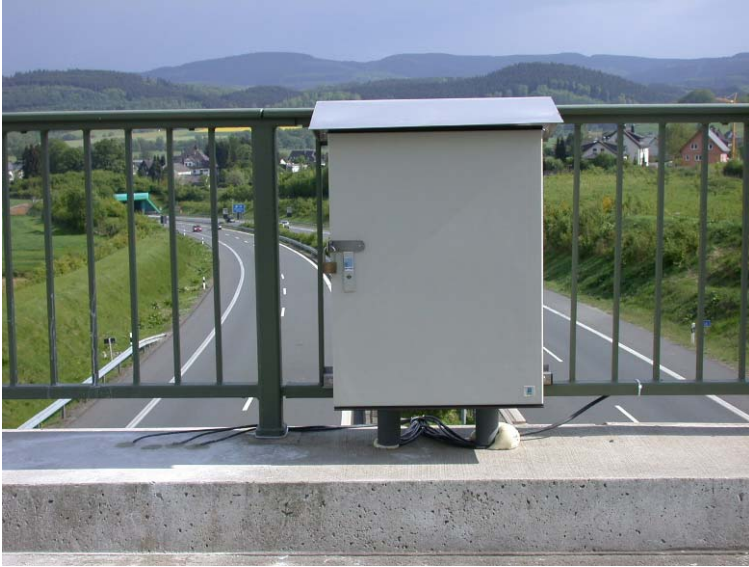
Figure 14. Measuring unit of exposure tests at a highway in Germany within the splashwater zone

As examples Figure 14 shows the measuring unit for exposure tests in the splash water zone of a highway in Germany and Figure 15 the exposure of concrete specimens in seawater environment on the island Helgoland. An extensive German research project on Corrosion Models for the Propagation Phase of Reinforcement Corrosion will continue this work (www.bam.de/dfg537.htm)

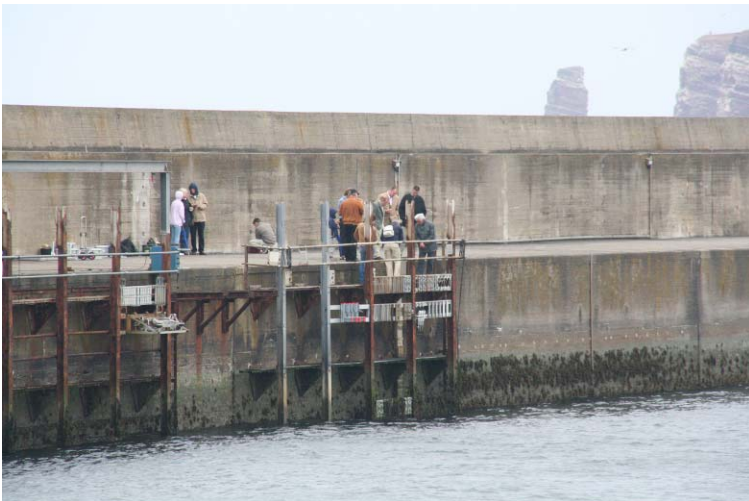
Figure 15. Exposure tests in seawater of the island Helgoland within a research project supervised by the University of Stuttgart
