**EFC WP16, 10th meeting,
EUROCORR'2004, Nice, Sept. 14, 2004**

THE PROBLEMATIC OF DISBONDING OF COATINGS AND CORROSION WITH BURIED PIPELINES CATHODICALLY PROTECTED

**Marcel ROCHE
Head of Corrosion Department
TOTAL S.A.**

Recent experience with 18'' oil Rabi-Cap Lopez pipeline (Gabon)

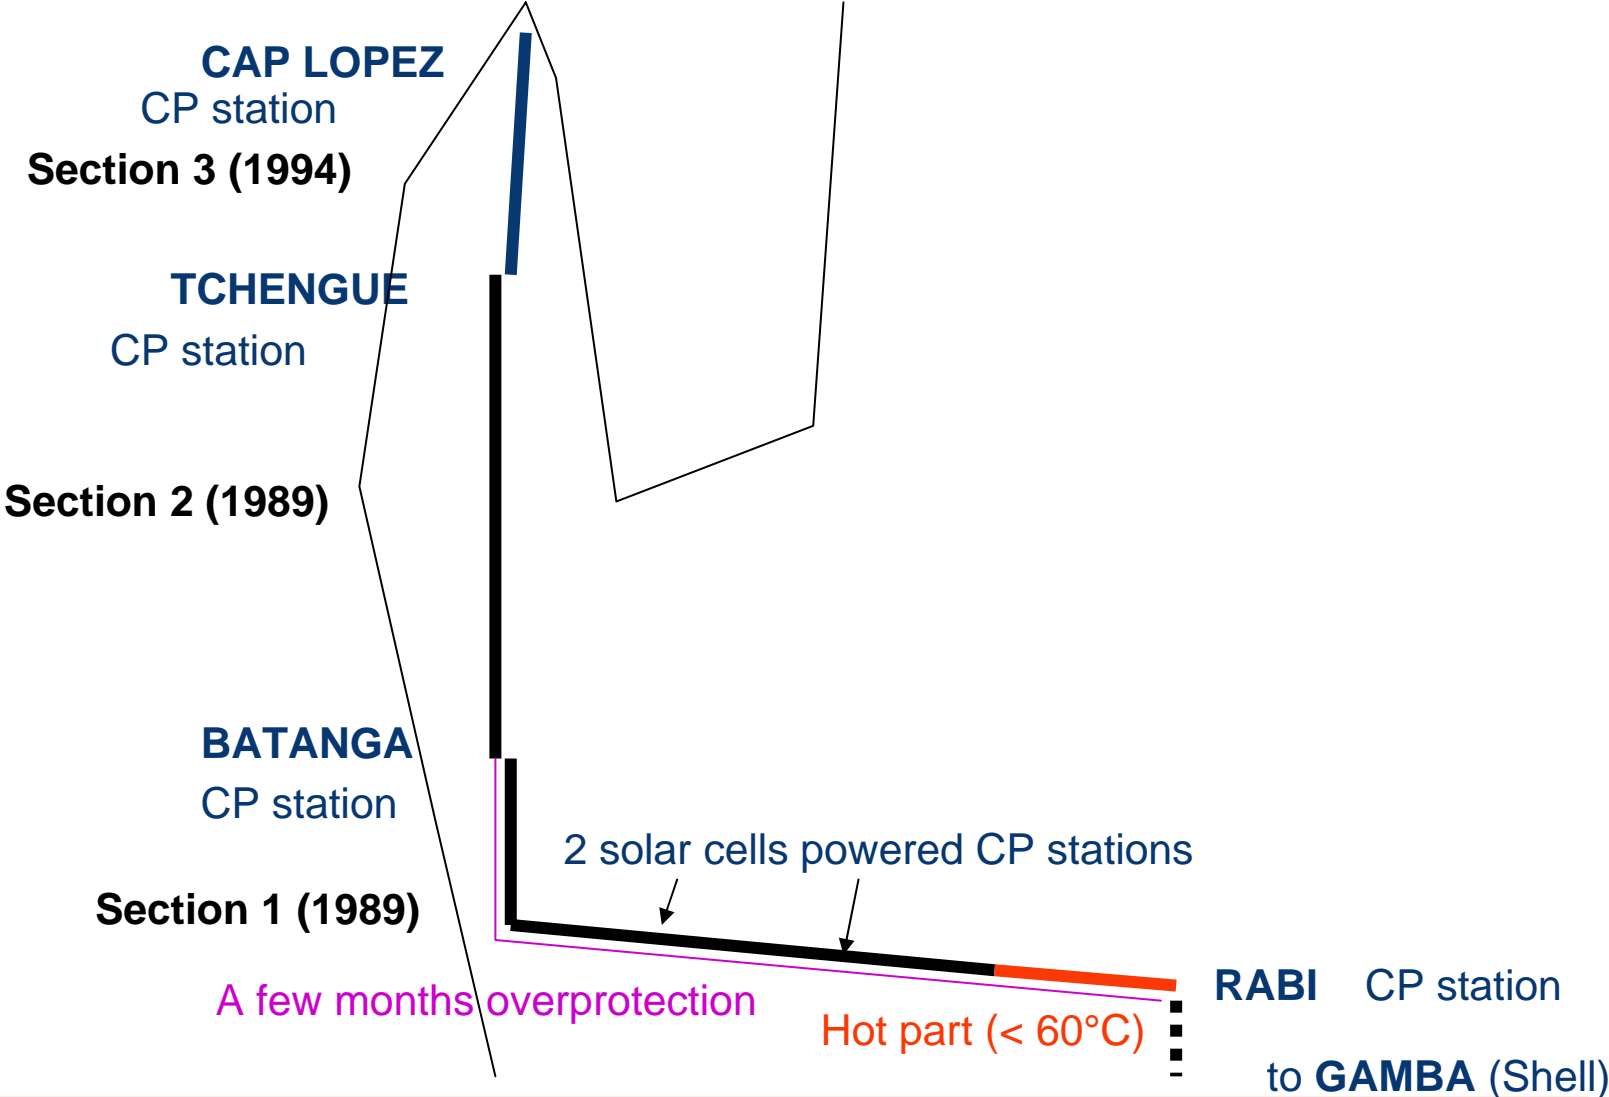
Recent experience with 18" oil Rabi-Cap Lopez pipeline (Gabon)

- **Pipe inlet temperature 60°C, constant** because heating above inversion point for prevention of wax deposition
- **Soil is wet compacted sand** (pH of sample 5.4)
- **CP stations using T/Rs at each extremity of sections + 2 automatic solar cells powered intermediate CP stations on section 1**
- **Section 1 has been overprotected (-6.4 V/SCE ON) in 1991 during 2 months due to dysfunctioning of one of the automatic solar cells powered CP station caused by lightning damage**

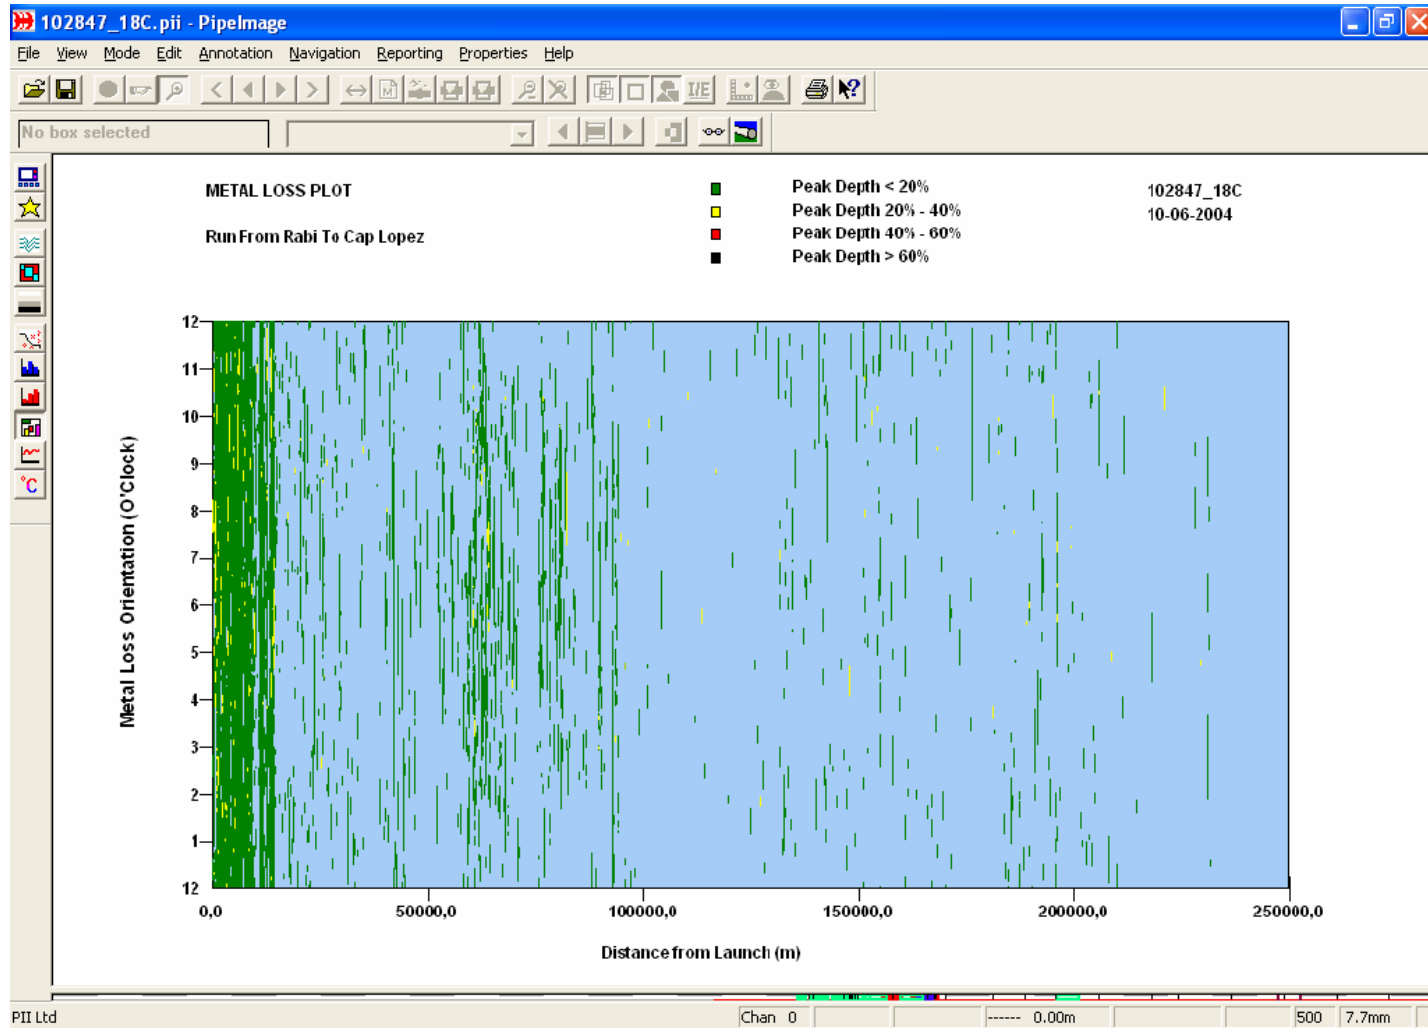
Recent experience with 18" oil Rabi-Cap Lopez pipeline (Gabon)

- Corrosion discovered **through ILI** in January 2004
- The intermediate report of ILI (MFL) reported 13600 features, the majority of which being in the **first 13 km (hottest side)**
- External corrosion, the majority (12494) at less than 20% wt, 1168 between 20 and 40%, 11 greater than 40%
- **Maximum 57%** at pK 2,237 km (**55°C**)
- No defect mechanically dangerous as per ASME B31G (ERF max = 0.441)
- **3 excavations carried out in April near pipeline inlet (pK 0.523, 2.189, 2.237 km) confirmed the ILI information**
- Potential measured with an electrode close to pipe during excavation: -1012 mV/Cu-CuSO₄

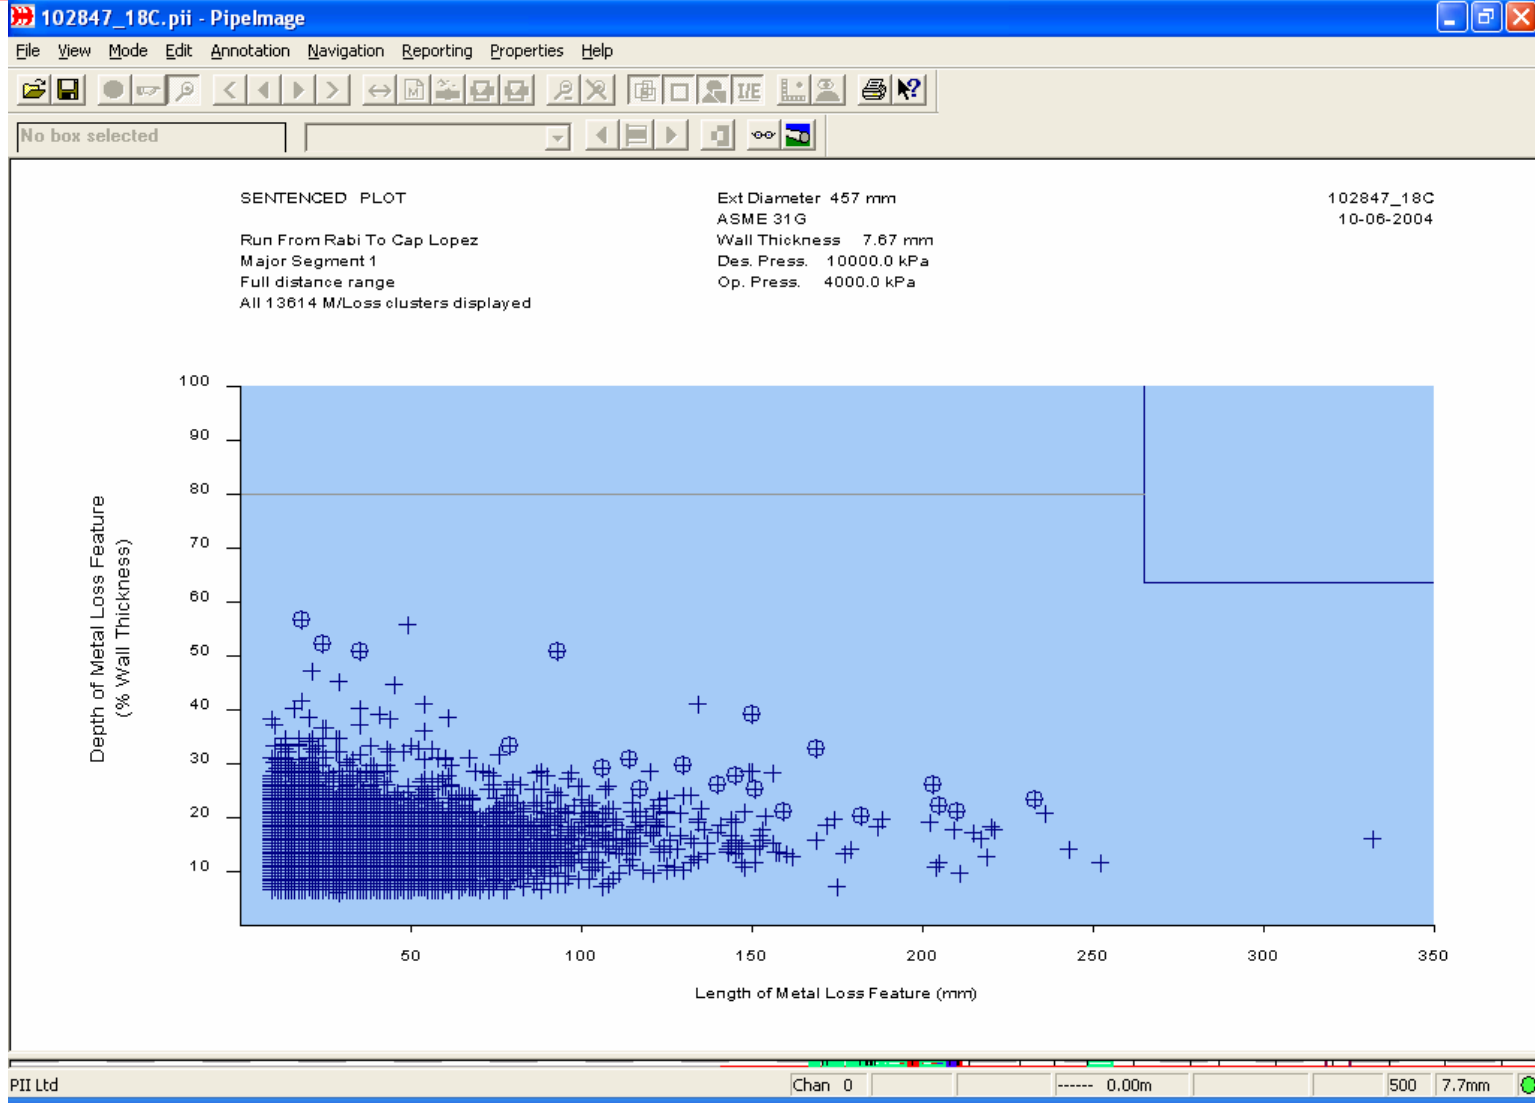
Recent experience with 18" oil Rabi-Cap Lopez pipeline (Gabon)

- **The major part of corrossions are under field joint coatings at girth welds: massive disbonding of HSS with steel** leading to corrosion caused by shielding effect
- Excavations reveal that in spite of a correct installation concerning applied heat shrinkable sleeves – no residual witness green points- and molten adhesive on the whole circumference, but **lack of bonding on plant applied PE coating** due to brushing limited to bevels of coating

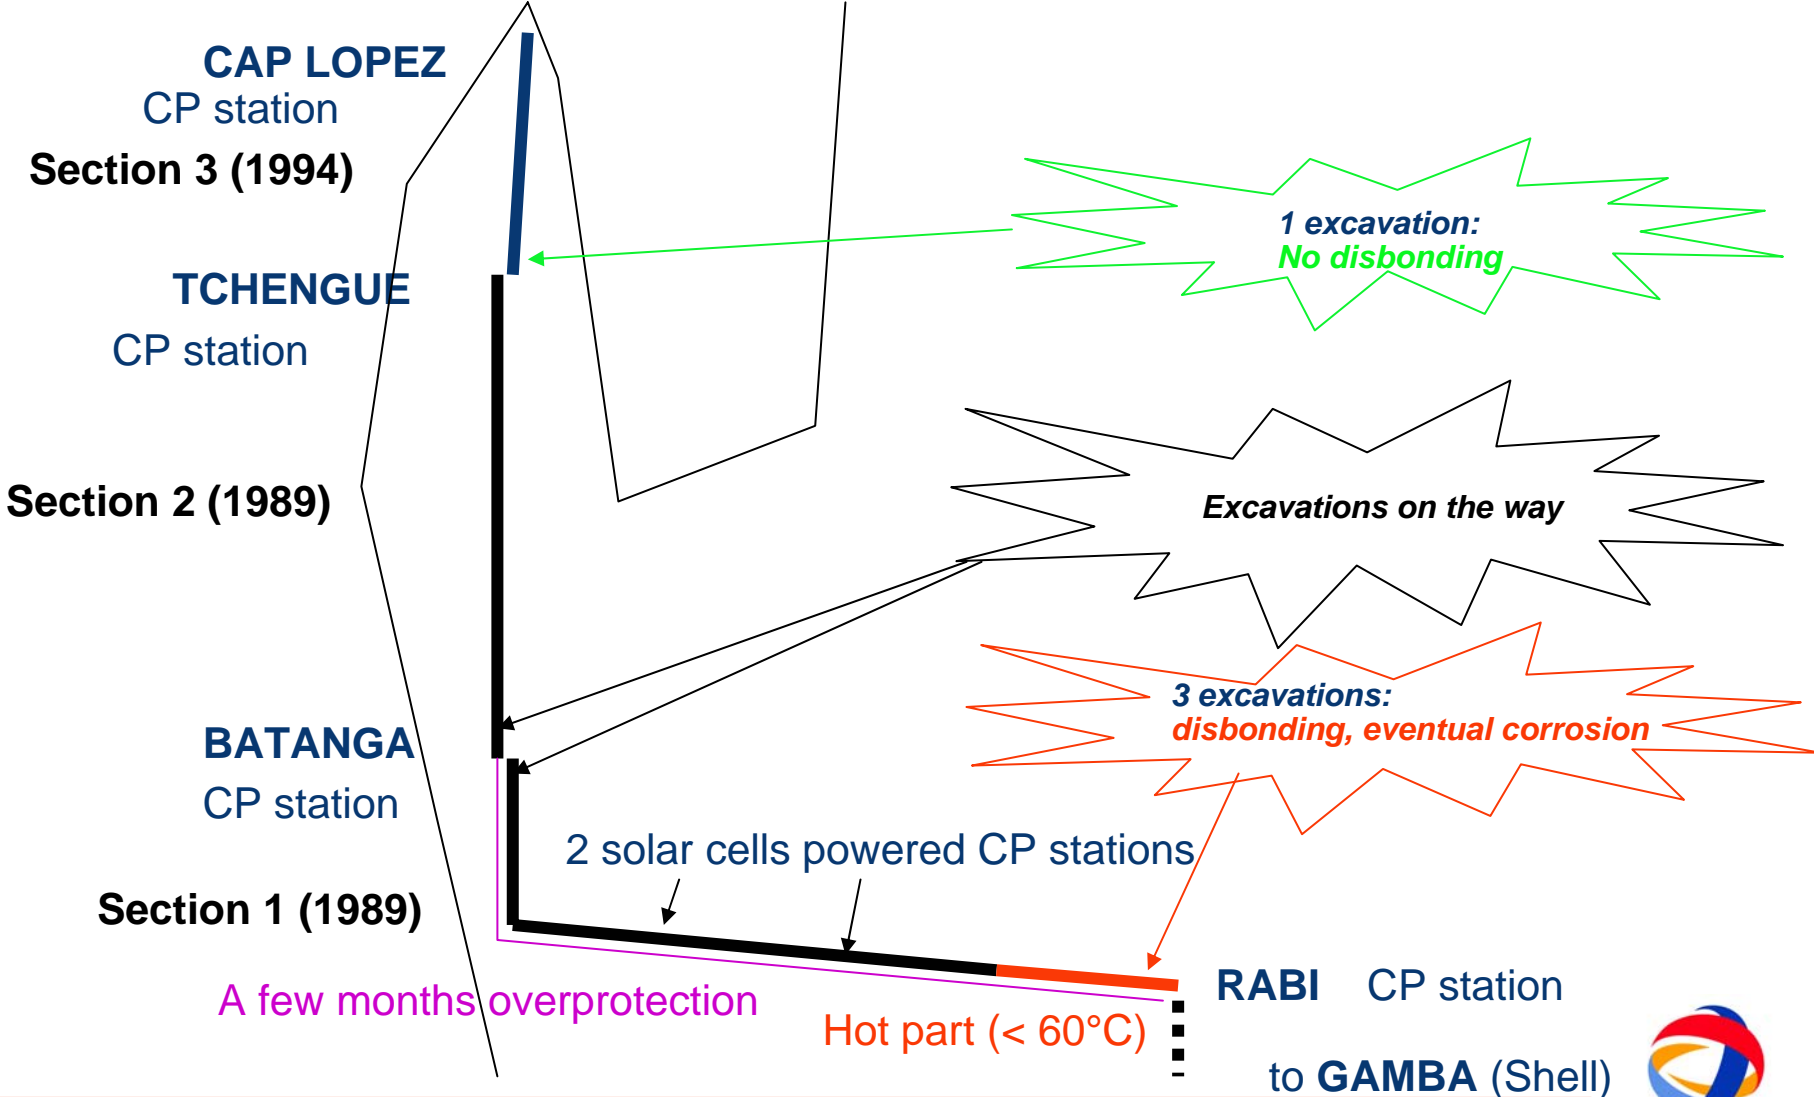
Recent experience with 18" oil Rabi-Cap Lopez pipeline (Gabon)

- Recent excavation at Tchenghé on **section 3** (started in 1997) reveals **no disbonding and no corrosion**
- Very wet area, PE coating covered with Bidim

- **New excavations** in different locations are on the way for determining the extent of disbonding and the effects of temperature and cathodic over-protection (especially at Batanga, on sections 1 and 2)
- **Precise temperature profile**
- **Correlation of disbonding with origin of plant coating**
- **Measurement of peeling strength on spare pipes and pipeline itself when some bonding remains**
- **DCVG and CIPS and any other “most advanced” methods** to be tested as soon as possible on damaged section. Call for bids on the way.
